Manhole Inspection Summary

Manhole # S25G__034MH

Insp Date: **4/15/08 4:32 AM**

Location Address: **1126 BALTIMORE ST**

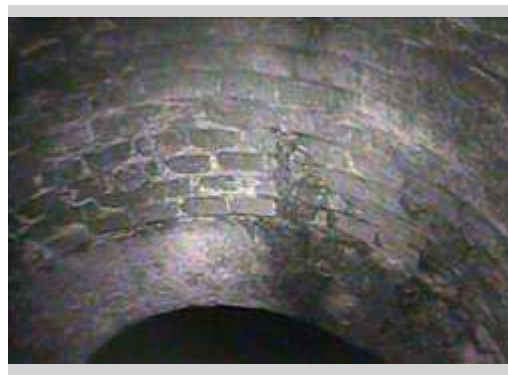
Defect 5

Infiltration: ☐ None ☐ Joint ☐ Cracks ☐ Mortar ☐ Roots ☒ **Wall**

BARREL INFILTRATION

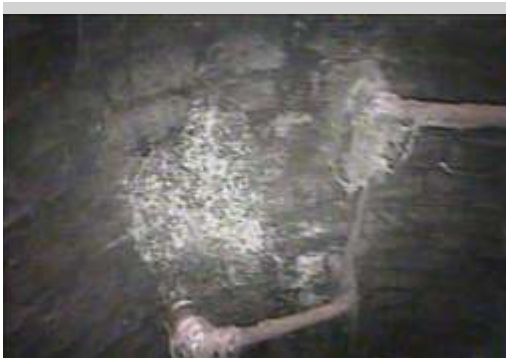
Defect 4

☒ **Evidence Of Surcharge**

Depth: **6** (ft.) ☐ Active Surcharge Present

SURCHARGE EVIDENCE ON STEPS

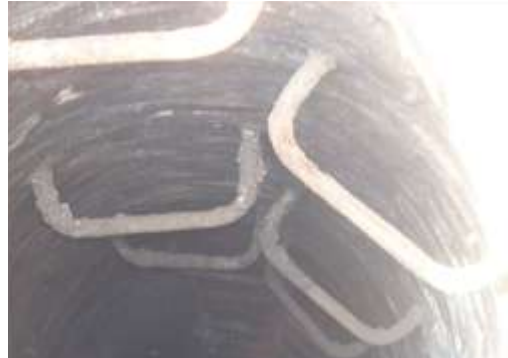
Defect 3

Count: **16** Missing: **0** ☒ **Corroded**

CORRODED STEPS

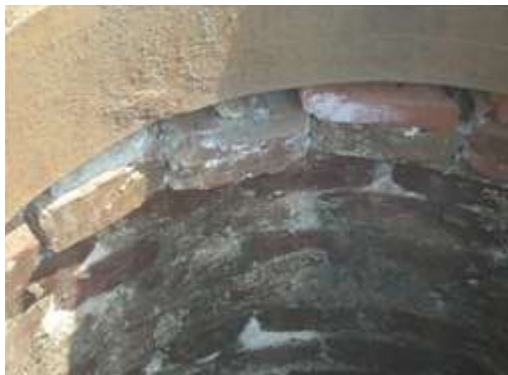
Defect 2

Condition: ☐ Sound ☐ Cracked ☐ Root Intrusion ☒ **Loose Brick** ☐ Deteriorated

LOOSE CORBEL BRICKS

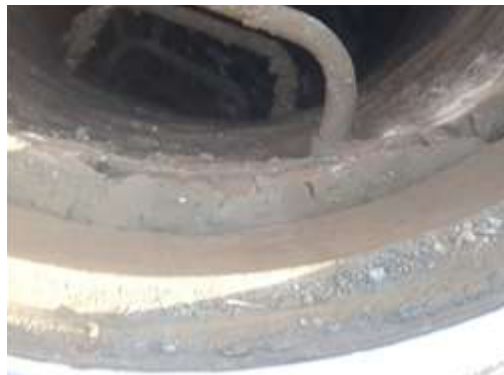
Defect 1

Offset: **1** (in.)

FRAME OFFSET
